#### CHINESE POWER PLANTS

#### KANSU PROVINCE

- (A) Chih-chin Hsia Thermal Power Plant
- (B) Lan-chou Thermal Power Plant (Hsi-ku)
- (C) Shang-hsuan Hydro Power Plant (Yen-kuo Hsia)
- (D) Shan-tan Thermal Power Plant
- (E) Shuang-cheng-tzu Thermal Power Plant
- (F) Yung-chang Thermal Power Plant
- (G) Yung-ching Hydro Power Plant (Liu-chia Hsia)

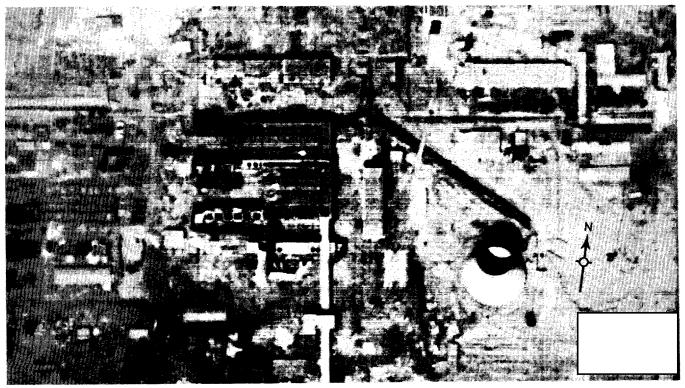
FIGURE 3 25X1

Approved For Release 2 <b>何(3月</b> 0 <b>5年)</b> RDP78T05161A001100010052-0
CIA IMAGERY ANALYSIS DIVISION
CHIH-CHIN-HSIA THERMAL POWER PLANT
CONCERDIORION ACCULATION
CONSTRUCTION ACTIVITY LEVEL OF PRODUCTIC
Completed housing for two boiler-generator units is evident. A masonry stack (A), two sets of flues, control
house and several support buildings are also completed. There is no apparent construction activity.
No apparent change None apparent.
First good quality coverage shows excavations for two additional boiler-generator sections. The substructure for a coal-unloading building
and several uprights for the coal-processing facility are visible; circular excavations for two additional cooling towers are evident. A trench has been dug and pipe probably laid for an underground water connection between the powerhouse and cooling tower.
Walls for the powerhouse addition are in place and the coal-processing facility

is nearly completed. Two pipelines are definitely laid in the trenching con- necting the powerhouse and cooling tower. Photography
reveals that the flue system is connected to the unit housing the blower/exhaust
fans; however, the latter
